Mean Time Between Failures (MTBF) for RESON hydrophones TC4032, TC4042

The following document is about MTBF (mean time between failures) for all RESON hydrophones with and without built-in preamplifiers.

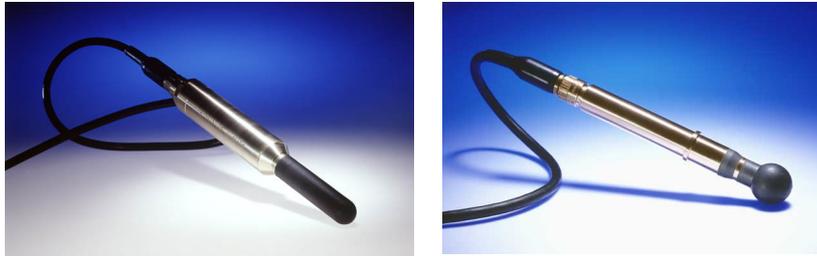
TC4032 on the left and TC4042 on the right.

The MTBF analysis is based on RESON COTS models TC4042 and TC4032. TC4042 is a spherical/Omni-directional hydrophone with built in preamplifier. Sensor tip is covered by Nitril Butadiene Rubber (NBR) rubber. Housing is made of sea-bronze.

TC4032 is low noise Sea-State zero hydrophone with Built-in 10dB Preamplifier. The sensor tip of TC4032 is covered by NBR rubber and housing is made of sea-bronze, the same kind as used for TC4042.
